Case Study

Detecting Electrical Faults in EV Paint Shop Pumps Using Vibration Data

Industry
Automotive

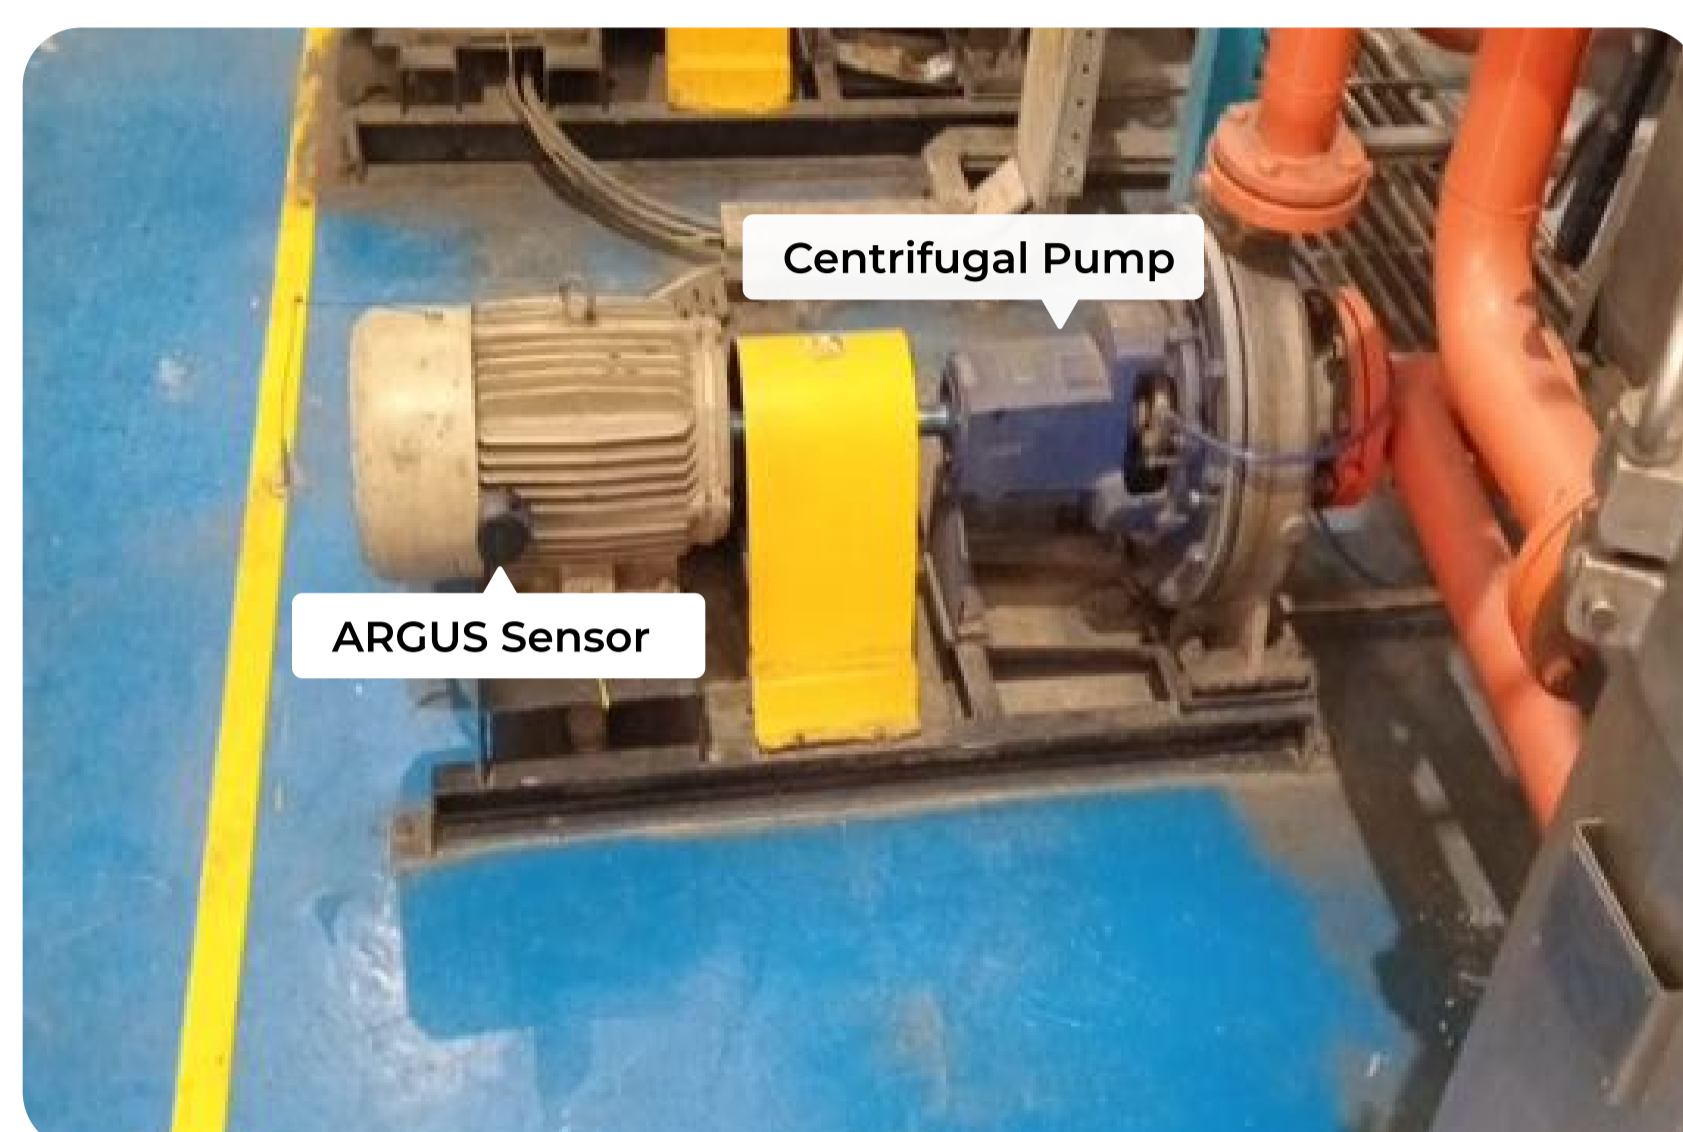
Figure 1: Centrifugal pump under monitoring

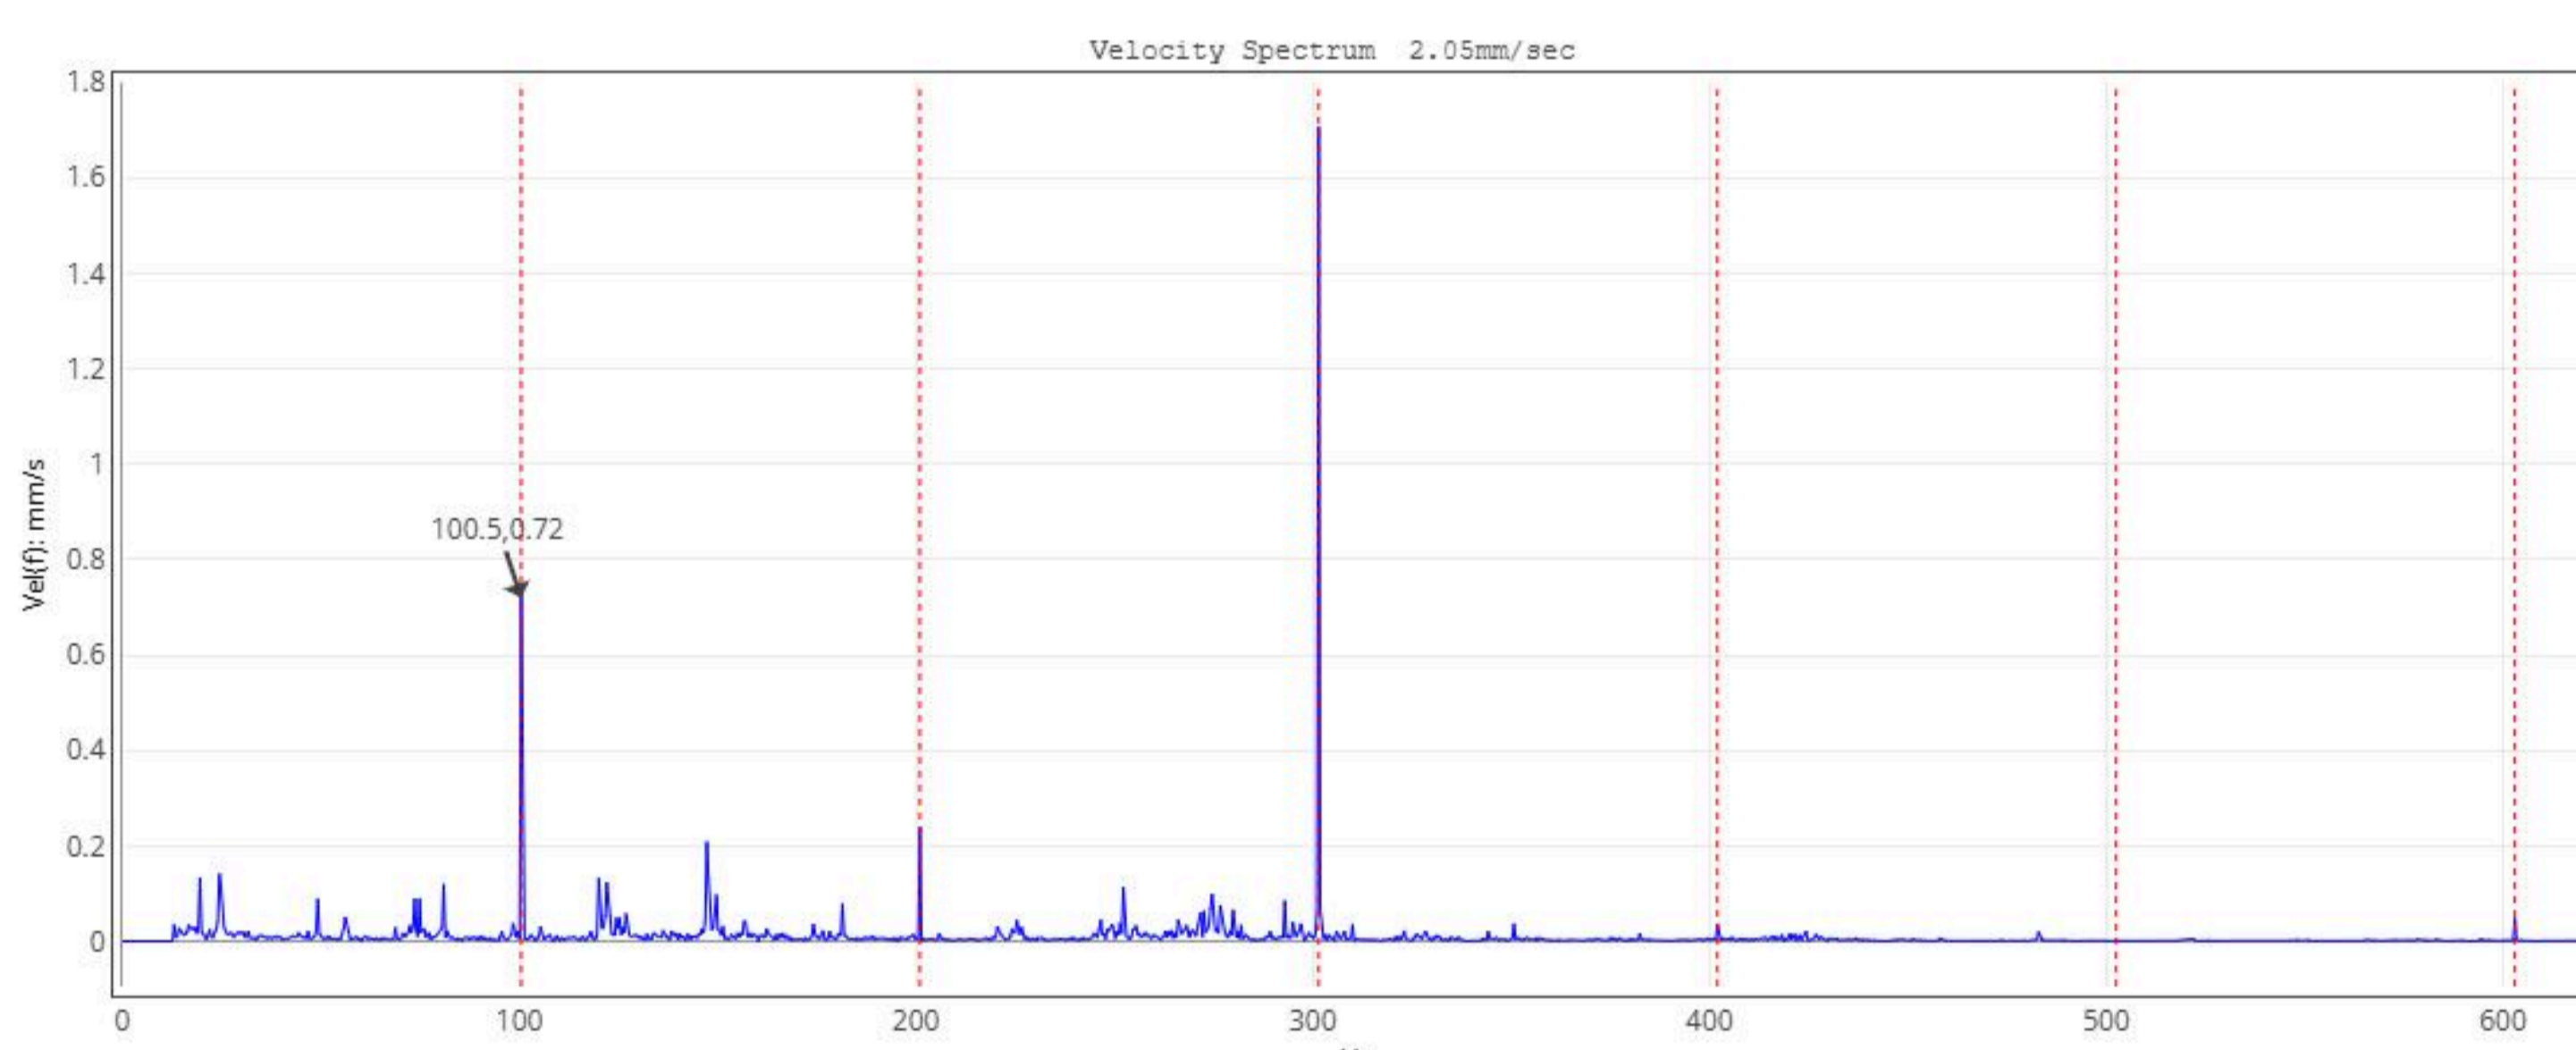
Although mechanical parameters appeared normal, FFT vibration analysis revealed prominent peaks at (which means 2X line frequency and its harmonics):

- 100 Hz
- 200 Hz
- 300 Hz

These harmonics — exact multiples of the 50 Hz supply frequency — are characteristic of electromagnetic anomalies in electric motors, not mechanical issues. These patterns indicated electromagnetic anomalies such as rotor bar or stator winding faults. Figure 3 illustrates the full FFT spectrum, with visible harmonic peaks at 100, 200, and 300 Hz.

Importantly, no bearing fault frequencies (BPFO, BPFI, BSF, FTF) were present, eliminating common mechanical fault sources like imbalance or misalignment.

Figure 3: Velocity spectrum with zoomed-in view showing peaks at 100Hz, 200Hz, 300Hz

Suspected Cause	Description	Recommended Test
Rotor bar defects	Broken or cracked rotor bars causing 100 Hz frequency	Perform motor current signature analysis (MCSA) for rotor bar defects to detect 45/55 Hz sidebands
Stator winding faults	Shorted turns or insulation breakdown	Conduct insulation resistance test for stator winding faults
Voltage imbalance	Uneven 3-phase supply inducing harmonic distortion	Measure and log line-to-line voltage
VFD-induced noise	Harmonics introduced by inverter	Run motor direct-on-line; if harmonics vanish, VFD is the source
