Case Study

How a “Noisy Pump” Turned Out to Be a Critical Fault: Real-World Vibration-Based Diagnostics in Pharma

The Setup: Vacuum Pump for Clean Pharmaceutical Processing

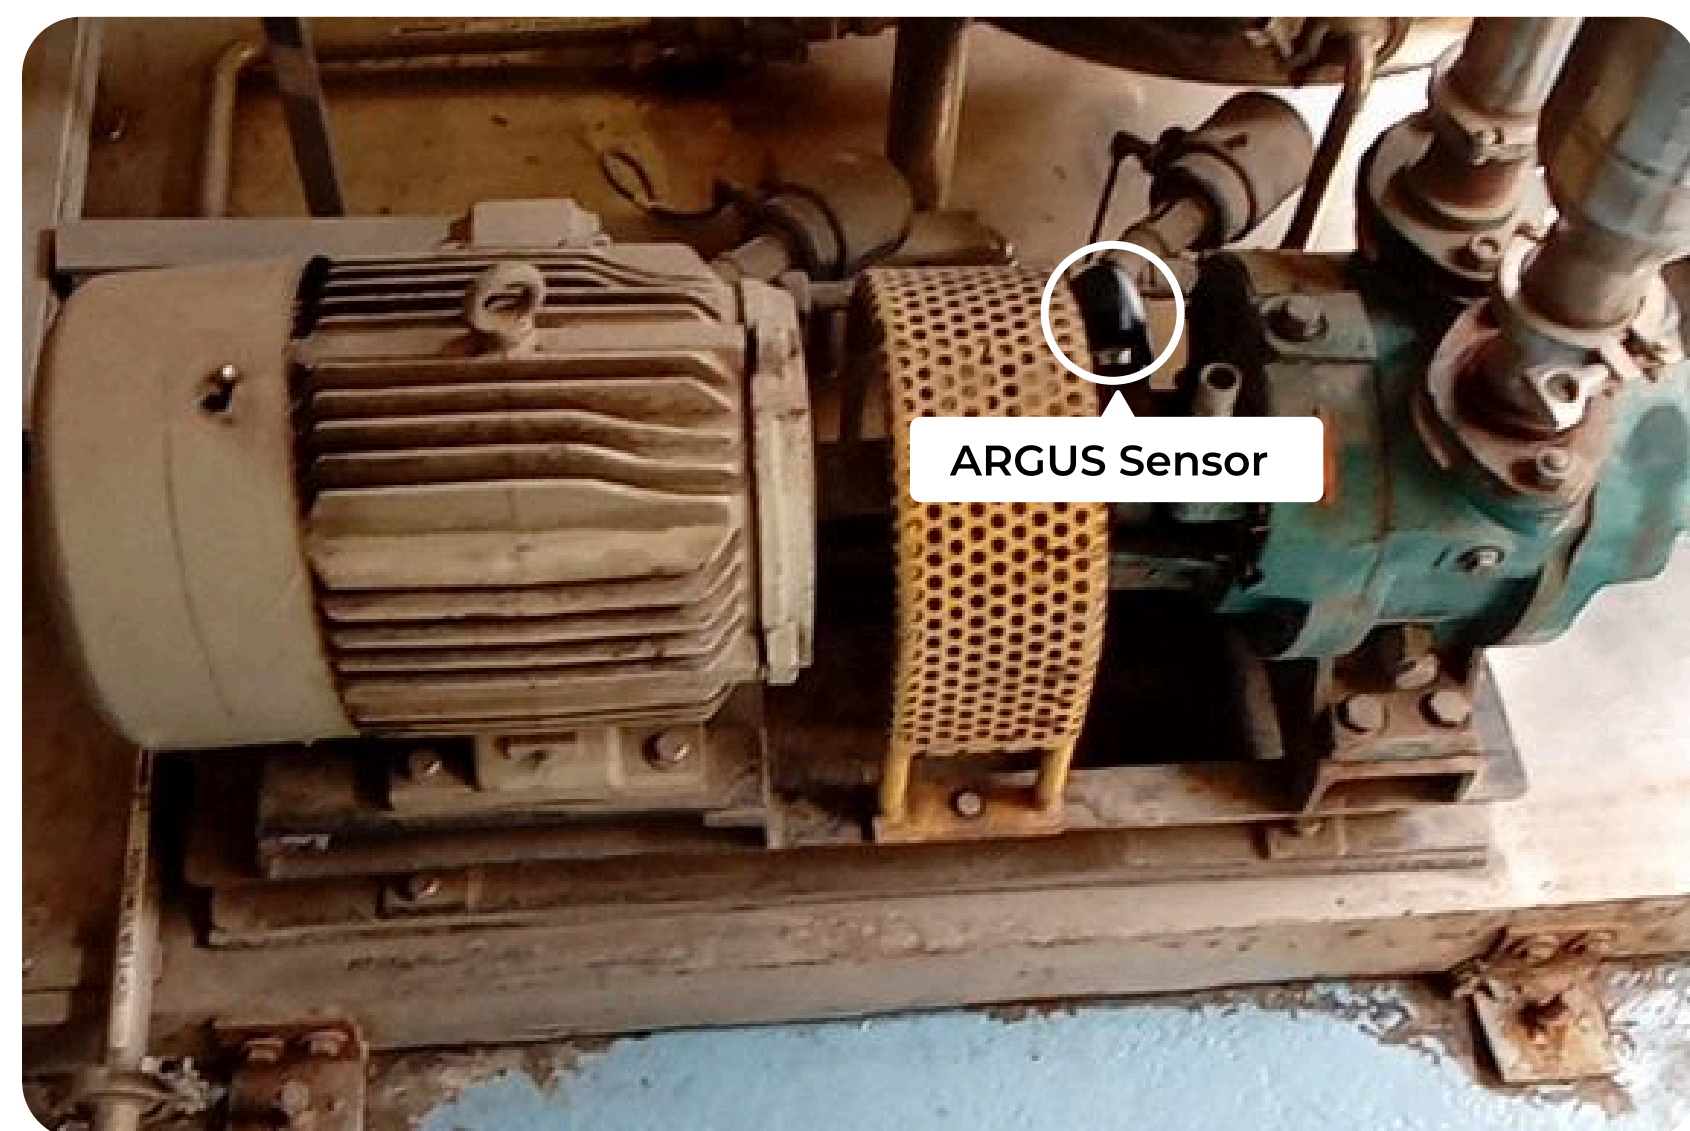
Figure 1 – Pump installation under evaluation

The vacuum pump, used to maintain clean, low-pressure environments essential for safe, contamination-free, and thermally gentle processing in pharmaceutical operations, was reported to be generating abnormal noise. The customer asked us to check the vibration levels during an ARGUS Portable Vibration Analyzer demo.

ARGUS sensors were mounted at four standard locations:

- Motor Drive End (MDE)
- Motor Non-Drive End (MNDE)
- Pump Drive End (PDE)
- Pump Non-Drive End (PNDE)

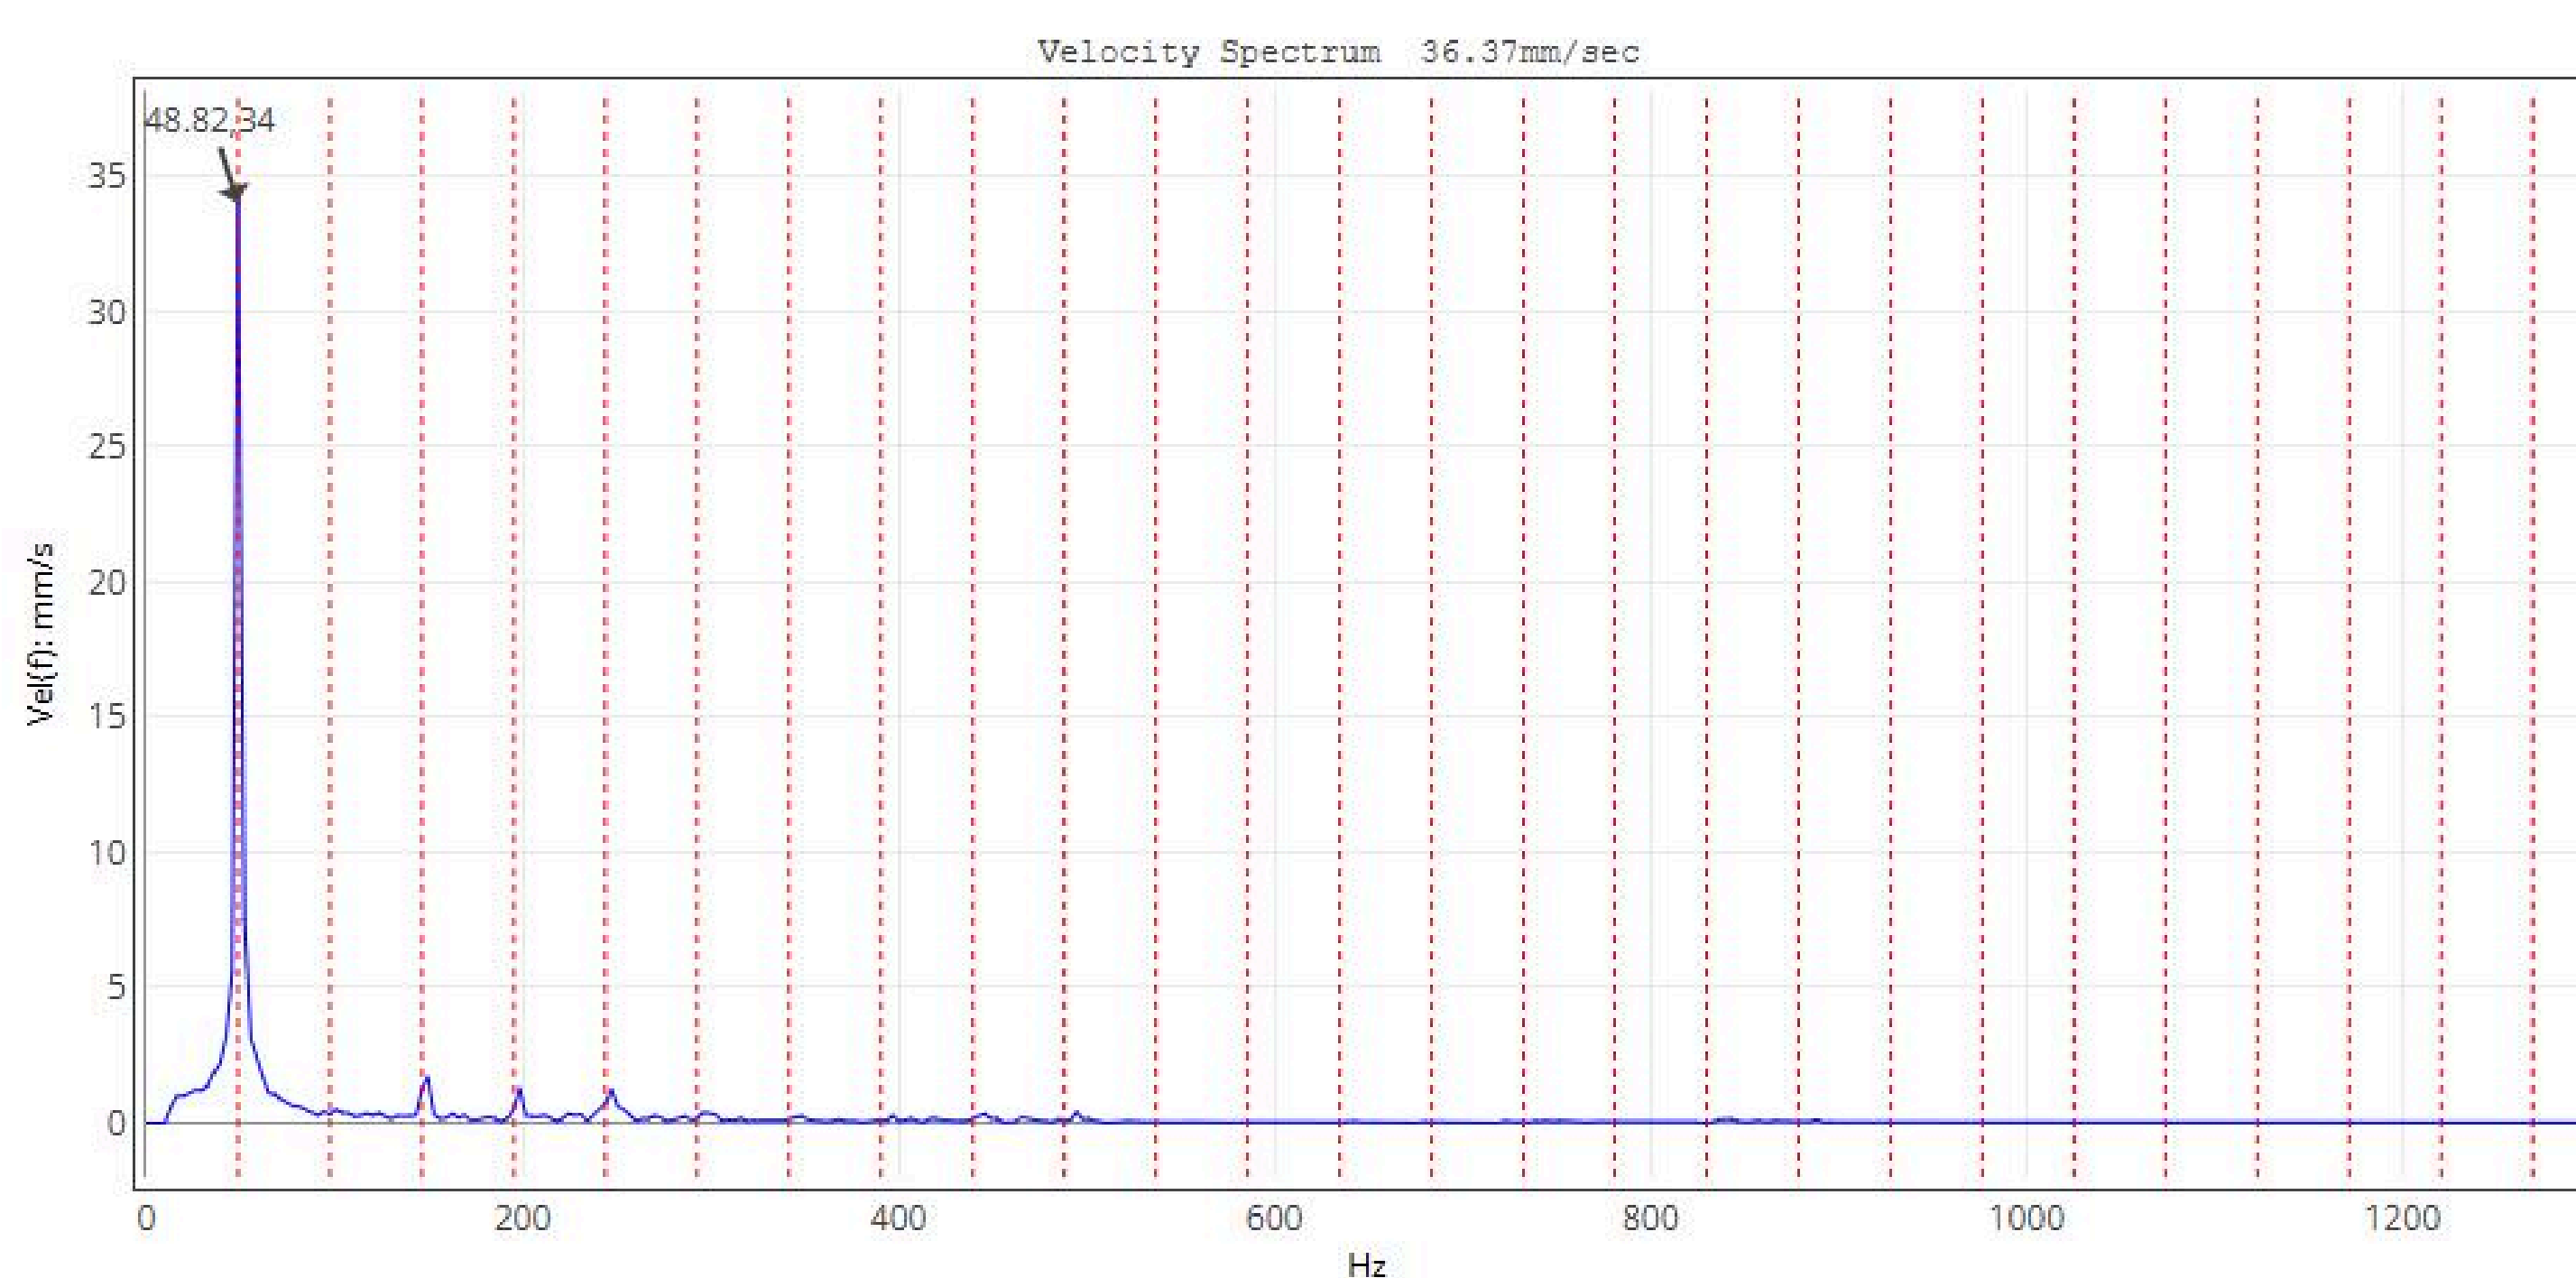
Figure 3a – Full FFT Spectrum from MDE-H

But the FFT spectrum from MDE-Horizontal told a different story:

- A strong 1× RPM component
- Pronounced 2×, 3×, 4×, and 5× harmonics — classic signs of structural issues

What Was Causing It: Soft Foot & Base Looseness

- The baseplate had not been shimmed
- No prior checks for soft foot had been done
- Some base bolts were loose

- Ensuring proper base bolt torque as per OEM recommendations
- Anchoring the frame securely to the base
- Shimming to eliminate soft foot
- Rechecking alignment after soft foot correction

- 1× and harmonic peaks dropped significantly
- RMS velocity returned below warning levels
