Case Study

Rapid Vibration Diagnosis Using ARGUS at a High-Speed Print Facility

Industry
Print Media

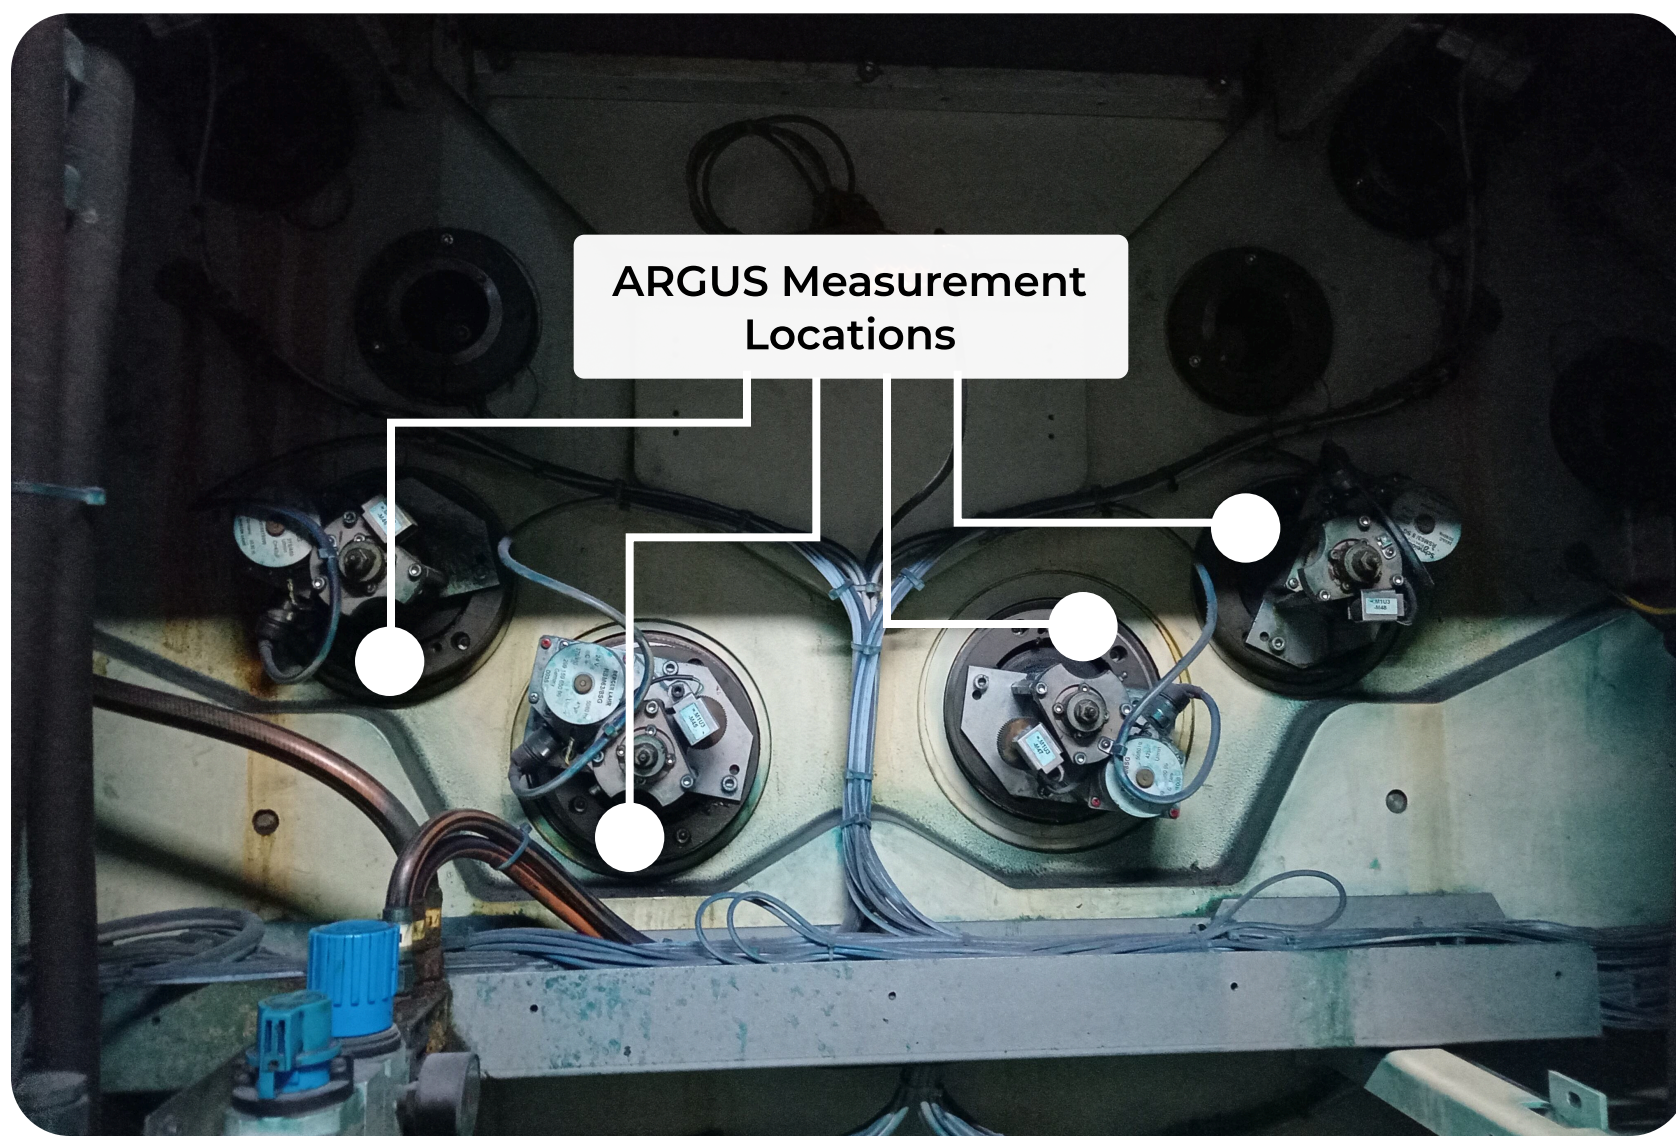
Figure 3: Sensor Deployment position on the accessible end

Due to structural limitations, only the rollers on Cylinder Side 1 were accessible. Rather than delay the diagnosis, the team adopted a focused approach: analyze the accessible rollers across both print units, compare results, and look for asymmetry or elevated vibration.

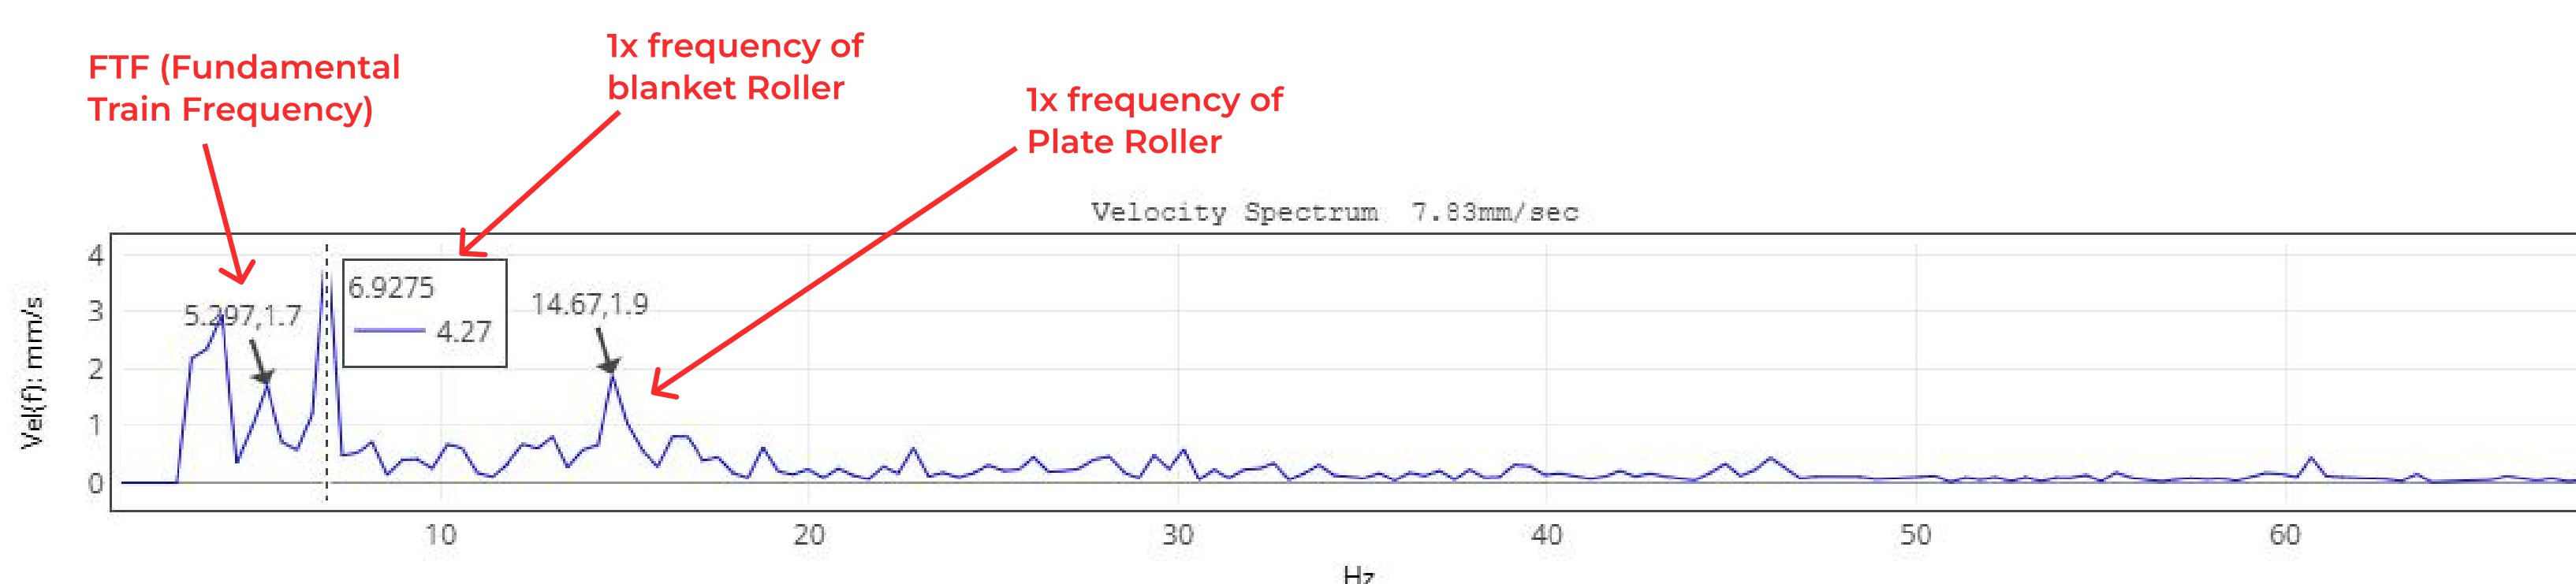
Figure 3: Velocity spectrum showing 1x roller speeds and bearing cage frequency (FTF)

To identify potential fault types, the ARGUS velocity spectrum was analyzed with an Fmax of 250 Hz. The spectrum showed moderate peak at ~5.3 Hz (Amplitude: 1.7 mm/s) — consistent with expected values for the Fundamental Train Frequency (FTF) of bearing cages. These peaks suggest a likely incipient bearing fault involving cage damage.

Additional peaks at 6.92 Hz and 14.67 Hz corresponded to the 1x rotational speeds of the blanket and plate rollers, respectively, and are considered normal machine components rather than fault indicators.

These results supported earlier findings and reinforced the need for a physical inspection during the next maintenance window.

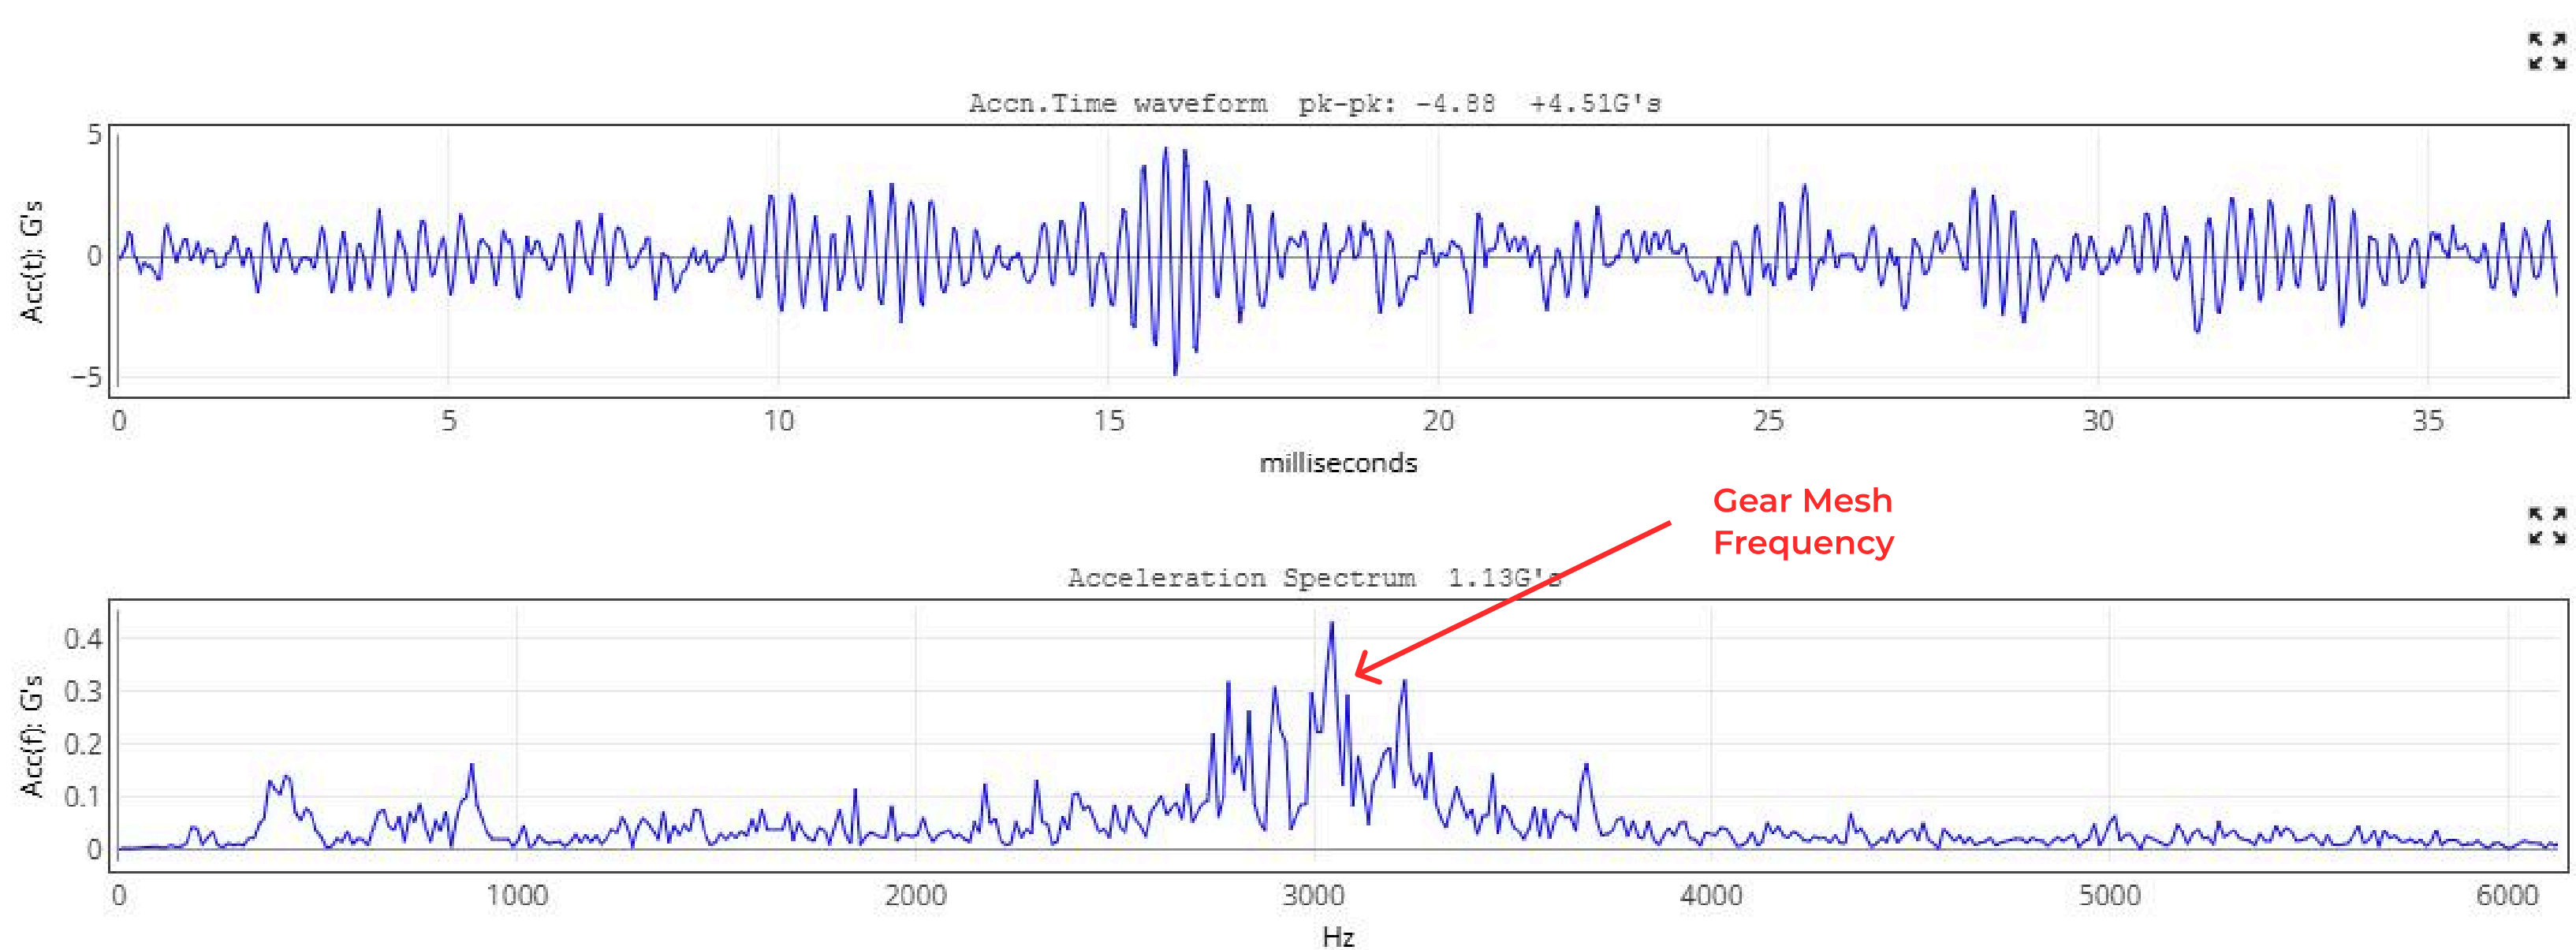
Figure 4: Acceleration waveform and spectrum confirming gear mesh activity near 3 kHz

To further validate the fault diagnosis, high-frequency acceleration data was analyzed up to 10 kHz. The acceleration spectrum revealed clear gear mesh activity around 3000 Hz, confirming mechanical interaction between meshing components. The corresponding time waveform exhibited periodic bursts, characteristic of impulsive excitation — often associated with minor gear tooth damage or meshing irregularities.
